# Manhole Inspection Summary

Manhole # S47E2\_002MH

Insp Date: **1/18/08 8:23 AM**

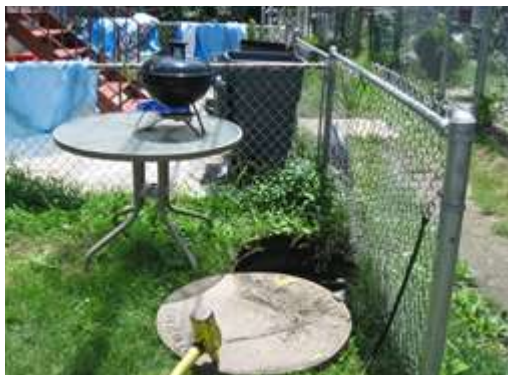
Location View

Comments **The manhole is located inside the fence of the backyard.**

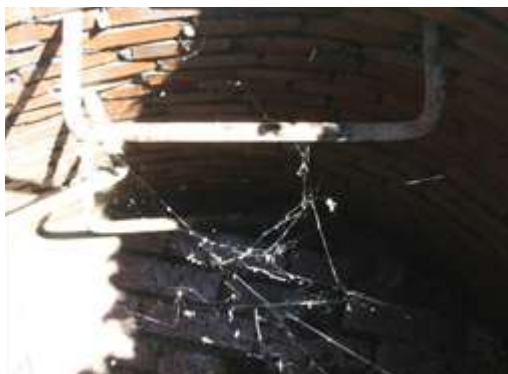
Steps

Count: **3** Missing: **0** ☐ Corroded

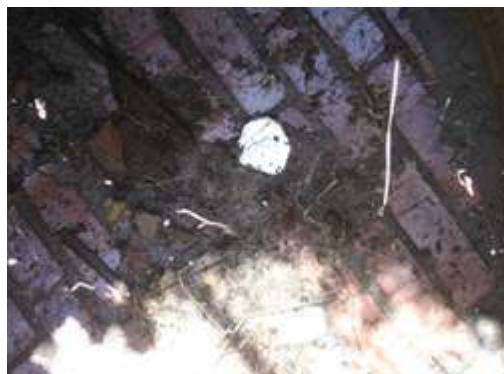
Defect 1

Trash/waste in manhole

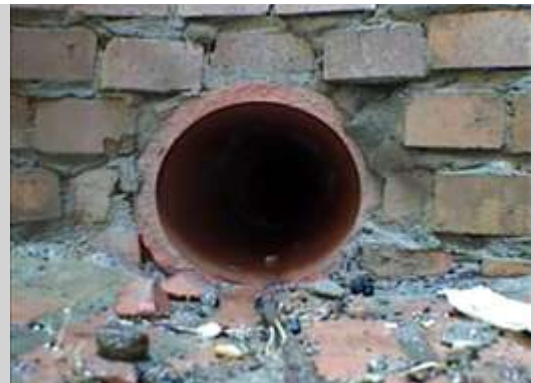
12 O'Clock Outflow

8 in. Circular Gravity Sewer  
Pipe Out @ 12 O'Clock

Pipe Material: **Clay** ☐ Pipe Lined

Deposits: ☒ None ☐ Mud ☐ Sludge ☐ Debris ☐ Grease

Infiltration: **None** Pipe Seal Cond: **Sound**
